Conclusion:

Inspector: Build Healer

Thermal images

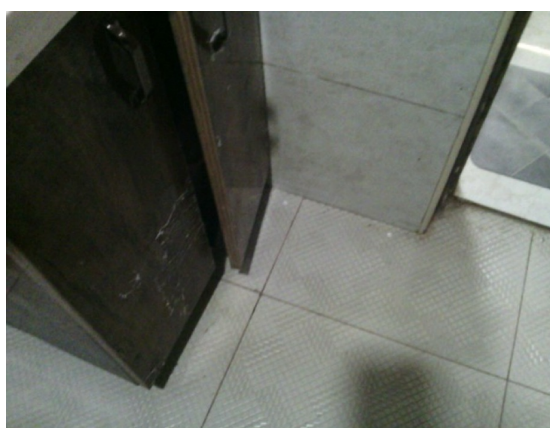
1.1 RB06976X.JPG

Hotspot:	29.2 °C	  Material:	Tiles
  Coldspot:	22.8 °C	  Emissivity:	0.91
  Center Spot:	27.1 °C	  Reflected Temperature:	23.0 °C

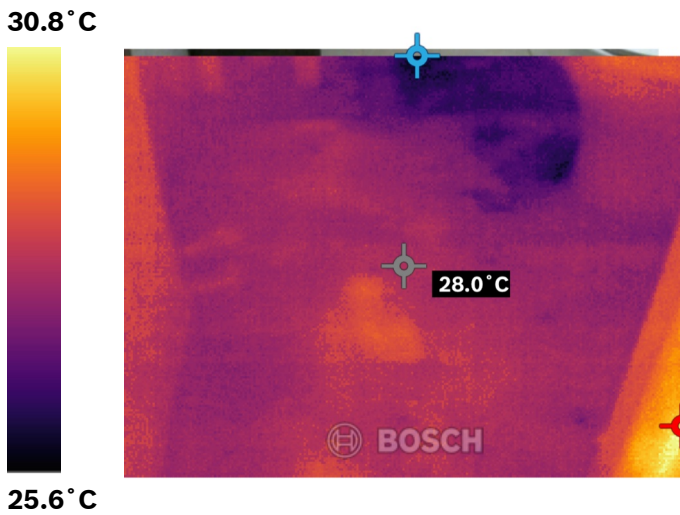
1.3 RB06974X.JPG

Hotspot:	30.8 °C	  Material:	Tiles
  Coldspot:	25.6 °C	  Emissivity:	0.91
  Center Spot:	28.0 °C	  Reflected Temperature:	23.0 °C

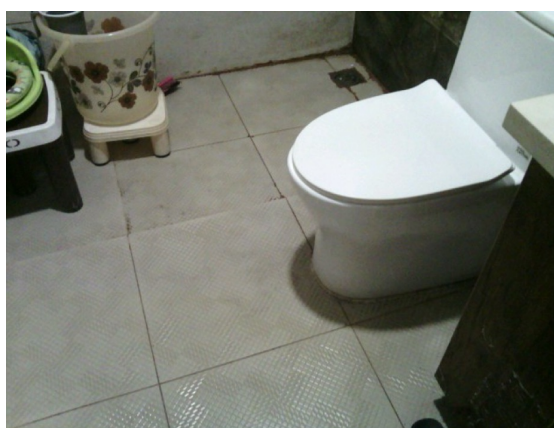
1.5 RB06972X.JPG

Hotspot:	31.0 °C	  Material:	Tiles
  Coldspot:	22.8 °C	  Emissivity:	0.91
  Center Spot:	26.6 °C	  Reflected Temperature:	23.0 °C

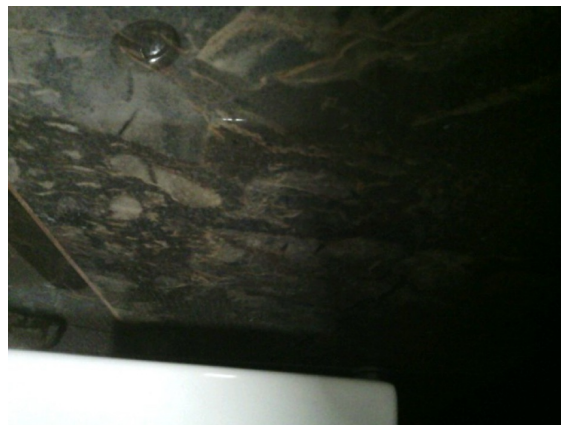
1.14 RB06961X.JPG

Hotspot:	30.5 °C	  Material:	Tiles
  Coldspot:	25.5 °C	  Emissivity:	0.91
  Center Spot:	27.9 °C	  Reflected Temperature:	23.0 °C

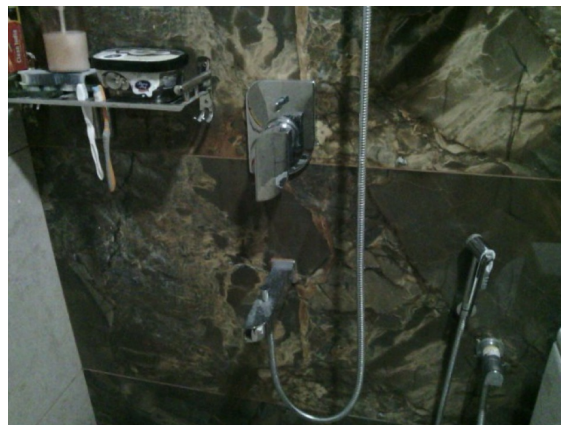
1.16 RB06959X.JPG

Hotspot:	49.8 °C	  Material:	Tiles
  Coldspot:	26.7 °C	  Emissivity:	0.91
  Center Spot:	29.6 °C	  Reflected Temperature:	23.0 °C

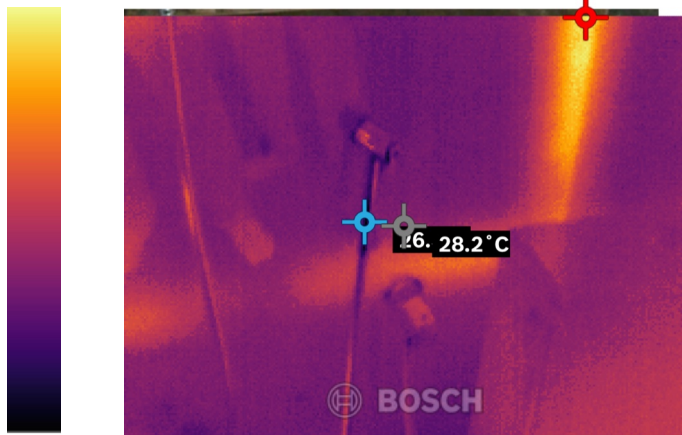
1.17 RB06958X.JPG

Hotspot:	31.3 °C	 	Material:	Tiles
 	Coldspot:	26.3 °C	 	Emissivity:	0.91
 	Center Spot:	28.2 °C	 	Reflected Temperature:	23.0 °C

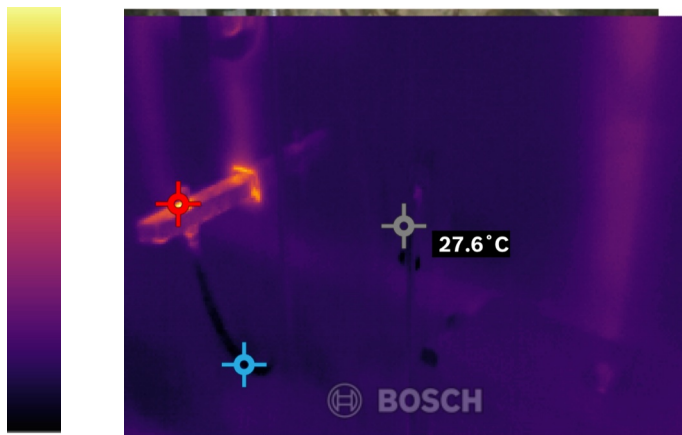
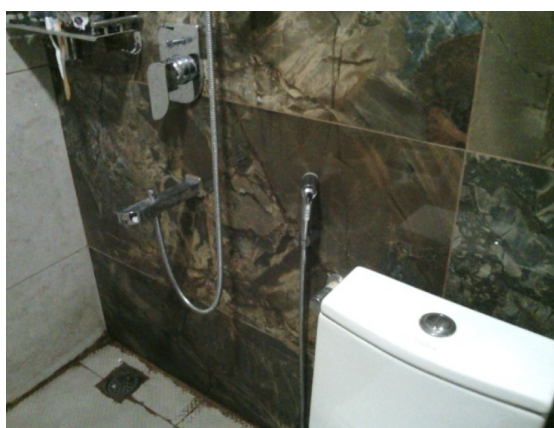
1.18 RB06957X.JPG

Hotspot:	44.5 °C	  Material:	Tiles
  Coldspot:	25.2 °C	  Emissivity:	0.91
  Center Spot:	27.6 °C	  Reflected Temperature:	23.0 °C

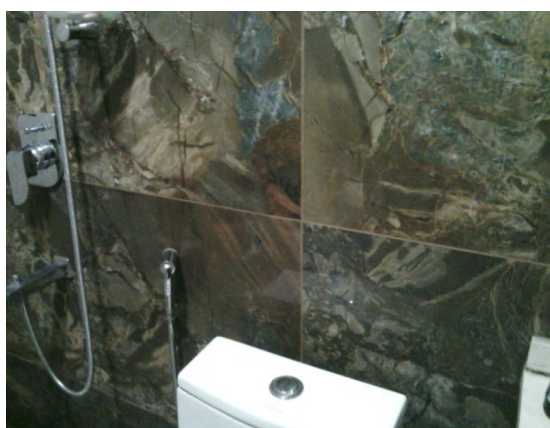
1.19 RB06956X.JPG

Hotspot:	31.8 °C	  Material:	Tiles
  Coldspot:	26.6 °C	  Emissivity:	0.91
  Center Spot:	30.1 °C	  Reflected Temperature:	23.0 °C

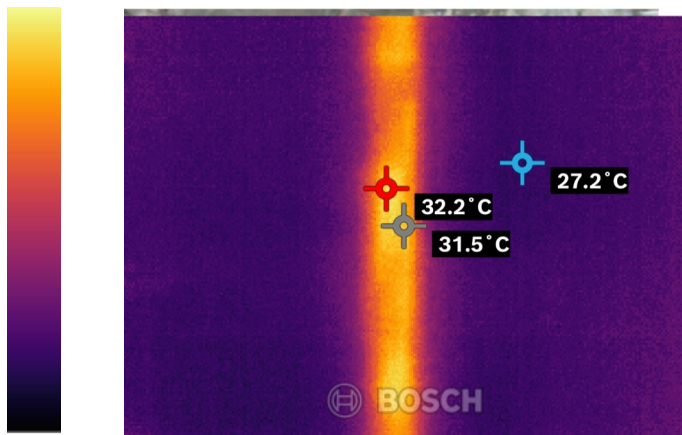
1.20 RB06955X.JPG

Hotspot:	32.2 °C	  Material:	Tiles
  Coldspot:	27.2 °C	  Emissivity:	0.91
  Center Spot:	31.5 °C	  Reflected Temperature:	23.0 °C

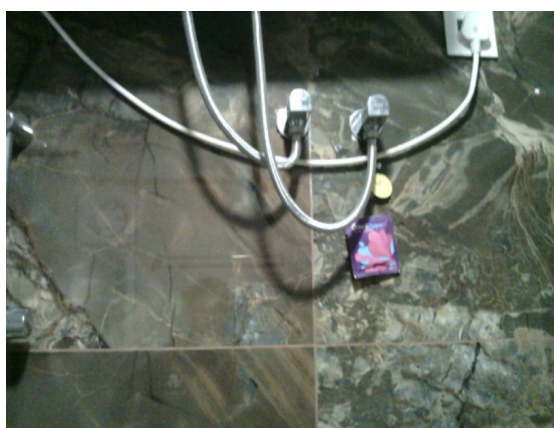
1.23 RB06952X.JPG

Hotspot:	40.5 °C	  Material:	Tiles
  Coldspot:	27.8 °C	  Emissivity:	0.91
  Center Spot:	28.8 °C	  Reflected Temperature:	23.0 °C

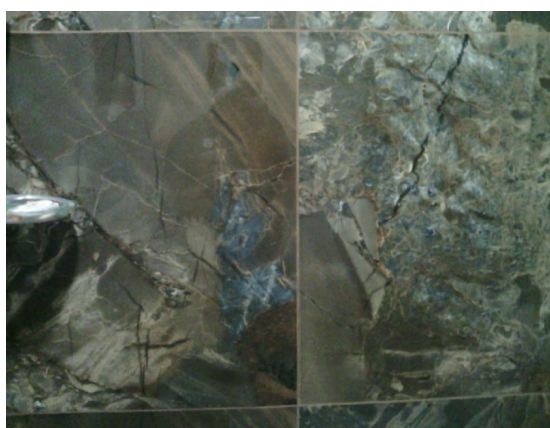
1.24 RB06951X.JPG

Hotspot:	32.1 °C	  Material:	Tiles
  Coldspot:	27.1 °C	  Emissivity:	0.91
  Center Spot:	30.3 °C	  Reflected Temperature:	23.0 °C

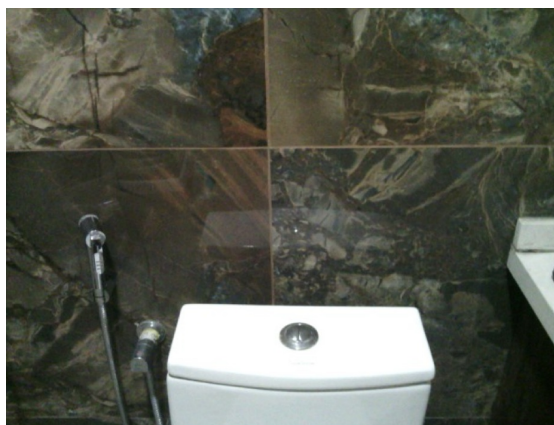
1.25 RB06950X.JPG

Hotspot:	31.9 °C	  Material:	Tiles
  Coldspot:	26.9 °C	  Emissivity:	0.91
  Center Spot:	28.4 °C	  Reflected Temperature:	23.0 °C

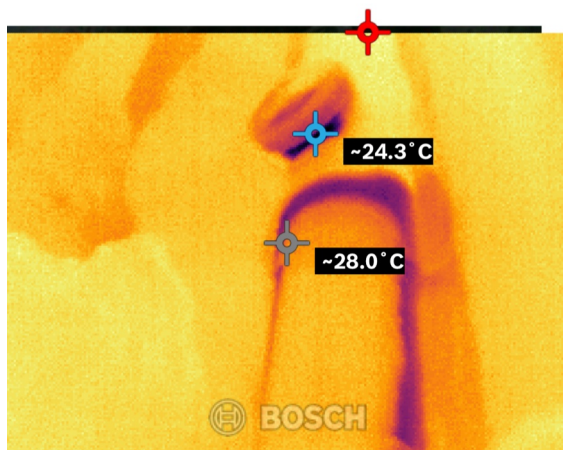
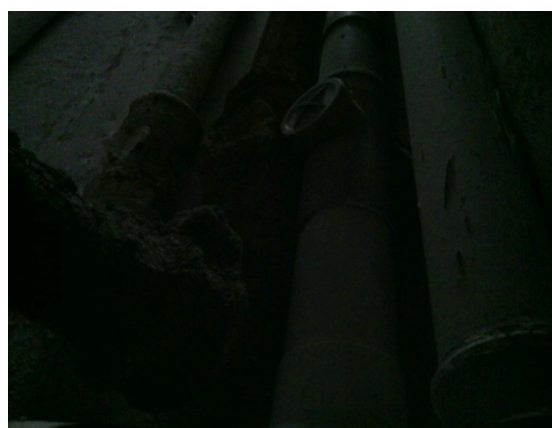
1.30 RB06945X.JPG

Hotspot:	~29.5 °C	  Material:	Tiles
  Coldspot:	~24.3 °C	  Emissivity:	0.91
  Center Spot:	~28.0 °C	  Reflected Temperature:	23.0 °C

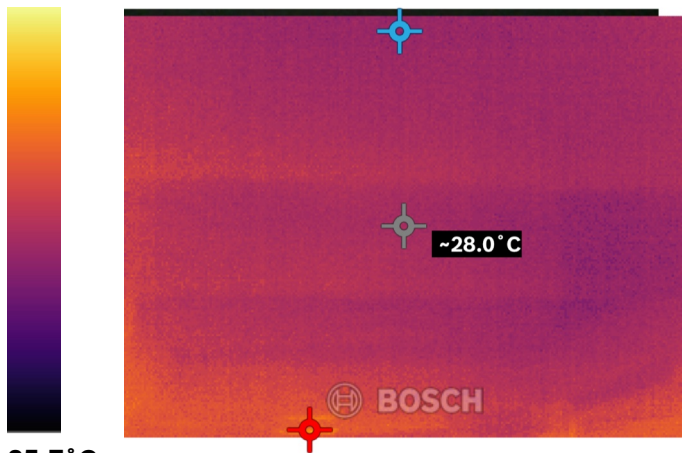
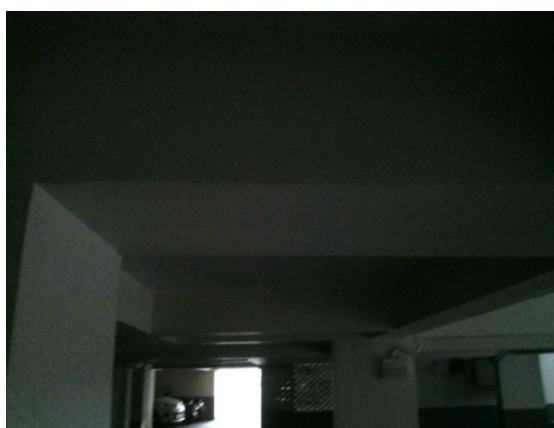
1.31 RB06944X.JPG

Hotspot:	~ 30.7 °C	  Material:	Tiles
  Coldspot:	~ 25.7 °C	  Emissivity:	0.91
  Center Spot:	~ 28.0 °C	  Reflected Temperature:	23.0 °C

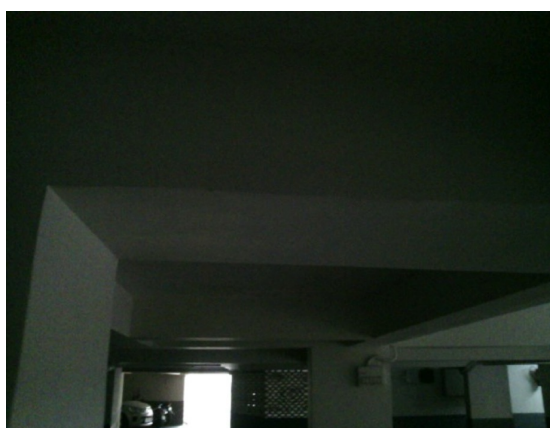
1.32 RB06943X.JPG

Hotspot:	~ 31.2 °C	  Material:	Tiles
  Coldspot:	~ 26.2 °C	  Emissivity:	0.91
  Center Spot:	~ 28.4 °C	  Reflected Temperature:	23.0 °C
